COMPREHENSIVE FACILITIES NEEDS ANALYSIS OF
THE MONT VERNON VILLAGE SCHOOL

OCTOBER 10, 2013

Barker Architects inc.

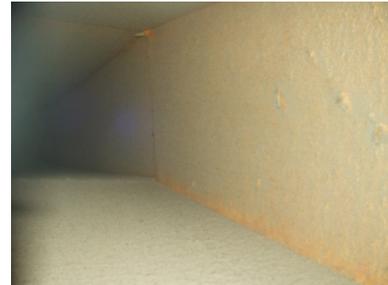
- ◆ Fiberglass is a known irritant.
- ◆ Dust is collecting on the inside of the duct.
- ◆ Taped seams and connections are failing allowing air to escape.
- ◆ The metallic outer coating has become brittle and is deteriorating.
- ◆ Fiberglass is not an air barrier thus reducing the effectiveness of the insulation and creating resistance to the air flow reducing the efficiency of the air handling units.

Figure 3 - Interior of Ductboard showing build-up of dust.

This only leaves replacement with metal ductwork the only remedial option. It may be worth cleaning and repairing the ductboard as is until new ductwork can be budgeted for.

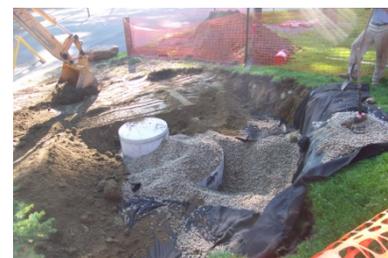
There is one area that does not drain properly. This is a low spot on the site and was used in the 2005 renovations as a dry-well location for drainage from the building. Apparently the dry-well is overwhelmed and the rainwater is not percolating into the water table. An additional dry-well located above the water table but downslope of the current dry-well would help with capacity.

Figure 4 - Drywell during construction in 2005.

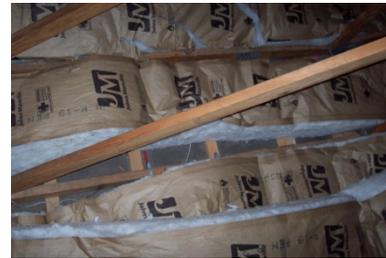
Figure 6 - Picture taken before renovations showing R=19 attic insulation not properly installed.

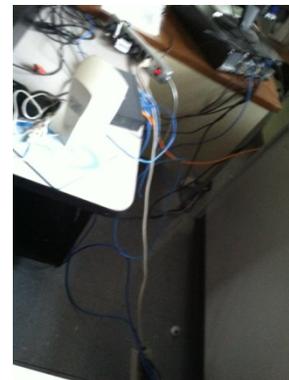
Figure 8 - Power strips plugged into power strips are against fire code.

It was observed in several classrooms where power strips were “daisy-chained” to create multiple additional outlets. This does not meet fire code. Additional power outlets should be installed. It may be necessary to install additional sub-panels to provide the necessary breaker space.

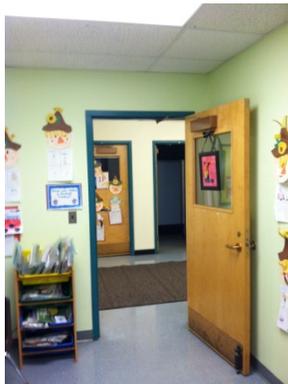
Figure 10 - Door with built-in door stop prevents closer from operating.

There are several corridor doors that are not fire rated. Additionally many classroom doors are being held open by “door chocks”. If keeping the doors open is important, then providing magnetic hold-opens tied to the fire alarm system would allow them to stay open while meeting code.

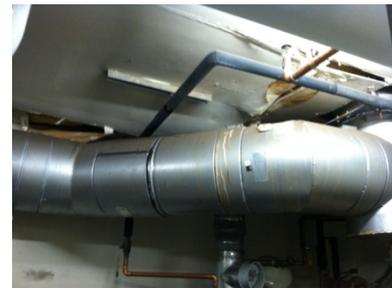
Figure 9 - Boiler room ceiling has breaches in the fire rating.

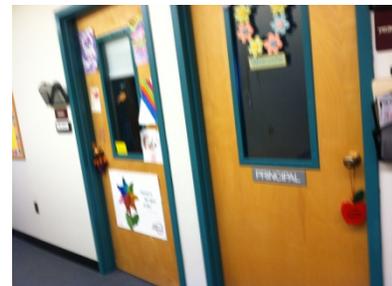
Figure 11 - The Principal's office is one of the doors that is not HC accessible.

Since the American Disabilities Act is a civil rights law and not a building code it is difficult to say what would immediately be required. It is reasonable to suggest that the accessible route into the classrooms be a priority and that the toilet facilities can be a future upgrade since some adequate facilities do exist.

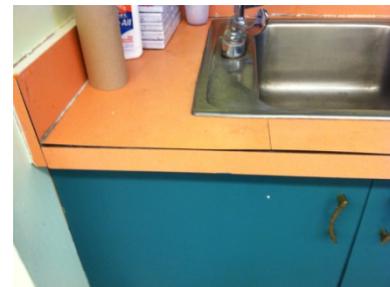
Interior finishes are mostly in very good condition. The notable exception is the casework in the older classroom wing of the building. Here the cabinets do not have a smooth surface and the countertops are delaminating. There are also pieces of missing baseboard or damaged walls from past water problems. Addressing the condition of the finishes is important for maintaining cleanliness as well as aesthetics.

Figure 12 - Plastic Laminate counter delaminating.

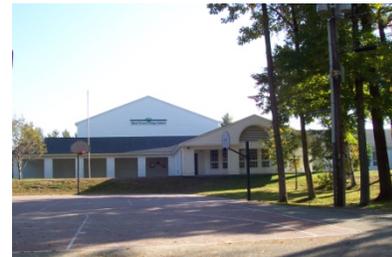
The major issue found here is that the front entrance is not directly connected to the main office and that if someone is allowed into the building, they immediately begin to mingle with students because both the kindergarten and the multi-purpose room are located off the same lobby that the main office is.

Figure 13 - Front Entrance and adjacent Kindergarten. Main office is behind kindergarten to the right.

A solution would be to move the main office into the current kindergarten. This would allow the office to have a direct connection with the entrance and have a better view of the exterior. The office and kindergarten are roughly the same square footage and each has toilet facilities making the swap relatively easy. An alternate would be a small addition next to the kindergarten which would allow space for the office staff who monitor the front door.

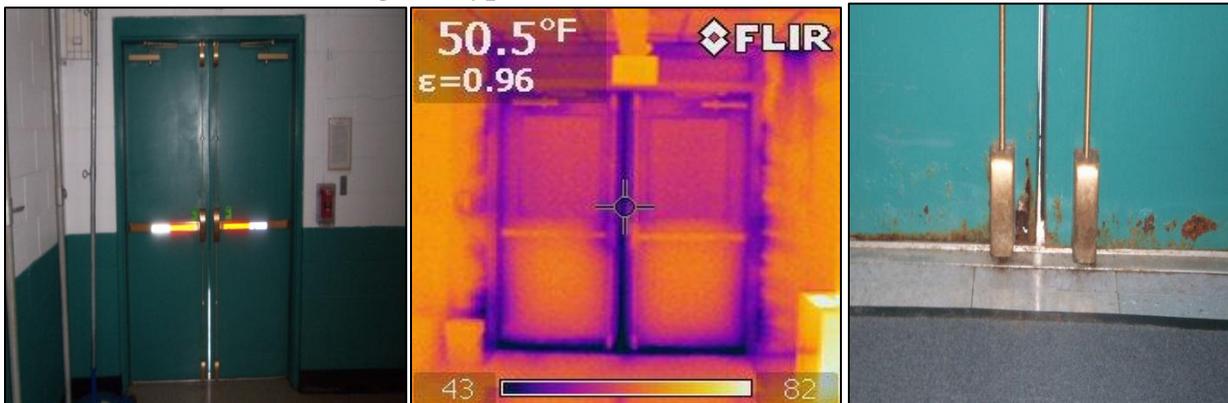
The exterior doors are in good working order and comprised of metal and glass. To reduce infiltration, the double doors need weather stripping length wise between each door. With rusting bottoms from years exposed to the elements, a few exterior doors are in need of replacement as well. We recommend installing commercial-grade weather strip kits along the middle portion of the double doors.

Image 1: Typical exterior door construction

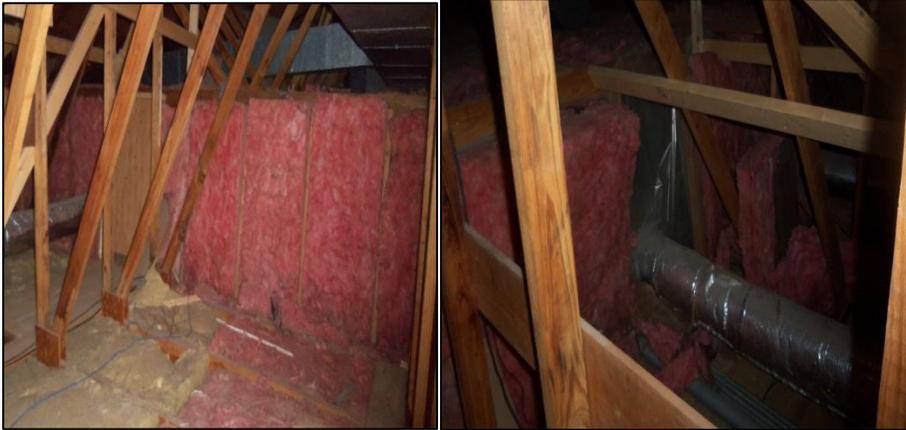
The air and thermal barriers in the attic were installed in 2005. Eight years later, the air barrier is in poor condition and no longer performing as a solid air barrier. The attic air barrier has holes and edges/seams that were not sealed during installation. As a result, there is a free flow of conditioned air leaking into the attic (winter conditions) and hot air leaking into the building (summer). The thermal barrier has varying levels of optimal installation. A fiberglass batt that lies flat against an air barrier and is fully encapsulated on all six sides will perform to the listed R-value. Fiberglass batting is never fully encapsulated in attics. However, fiberglass batting can perform quite well if it’s installed properly. Much of the fiberglass batting in the MVS attic was originally installed to manufacturer’s specifications. However, over time the fiberglass batting has fallen down (on the knee walls), been moved and not replaced (during wire or HVAC

Image 3: Attic knee walls with poorly sealed HVAC penetrations

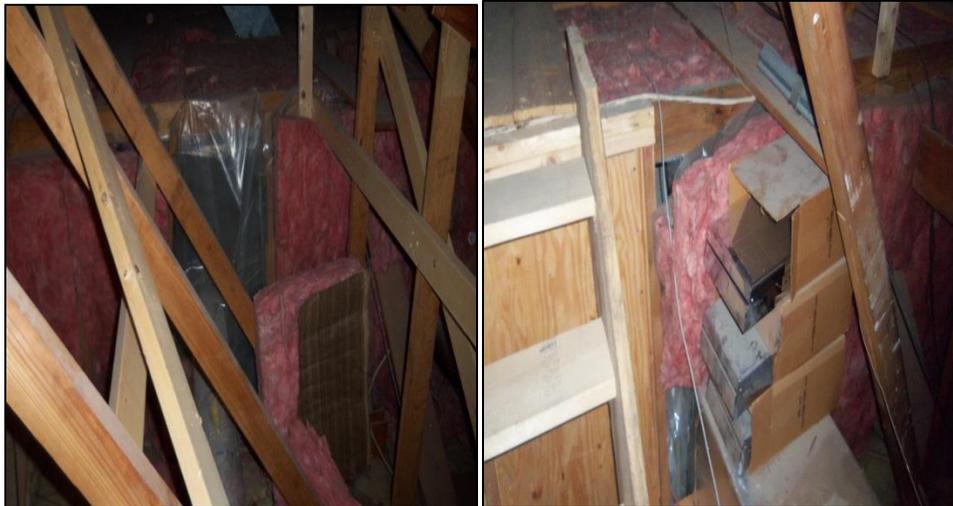
installations) or is now missing. See images 3 and 4 for a depiction of poorly installed knee wall insulation.

Image 4: Attic knee walls with poorly installed insulation

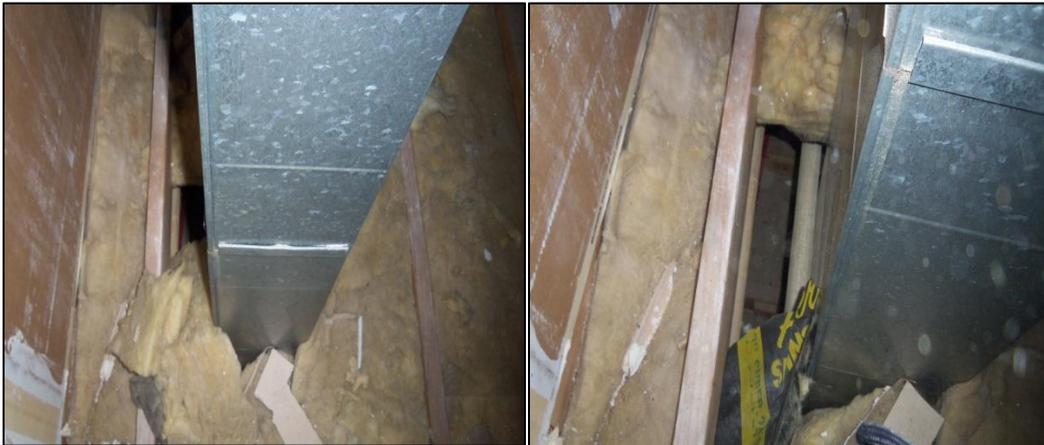
Image 6: HVAC penetrations through the sheetrock ceiling above the

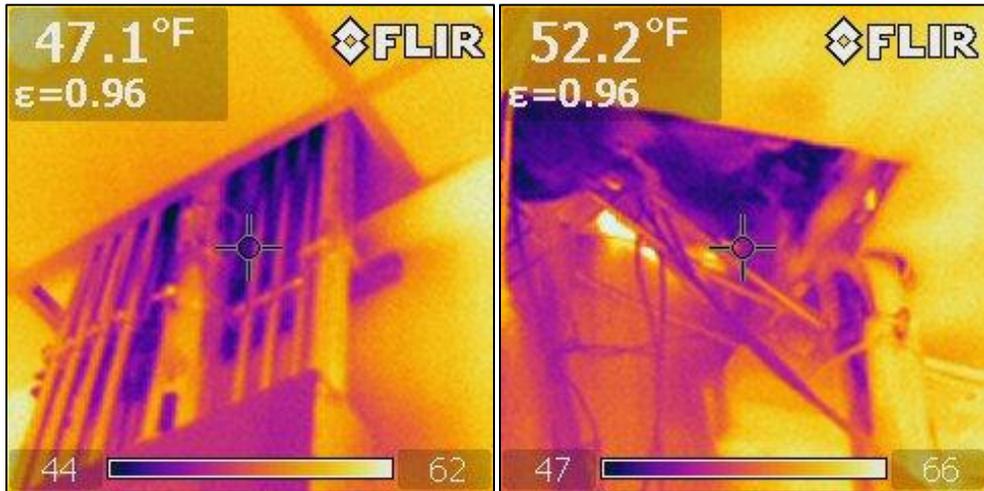
Image 7 depicts the result of an improperly sealed air barrier and underperforming thermal barrier. The electrical chases extend through the acoustic tile ceiling, puncture through the air barrier with fiberglass batting plugging the hole against leakage.

Image 7: Penetrations through the attic into the conditioned space

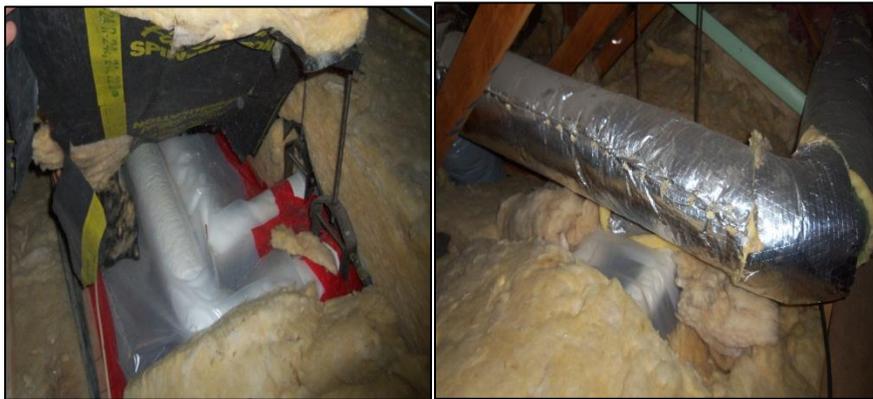
Image 8: A properly sealed vapor barrier, but poorly installed insulation

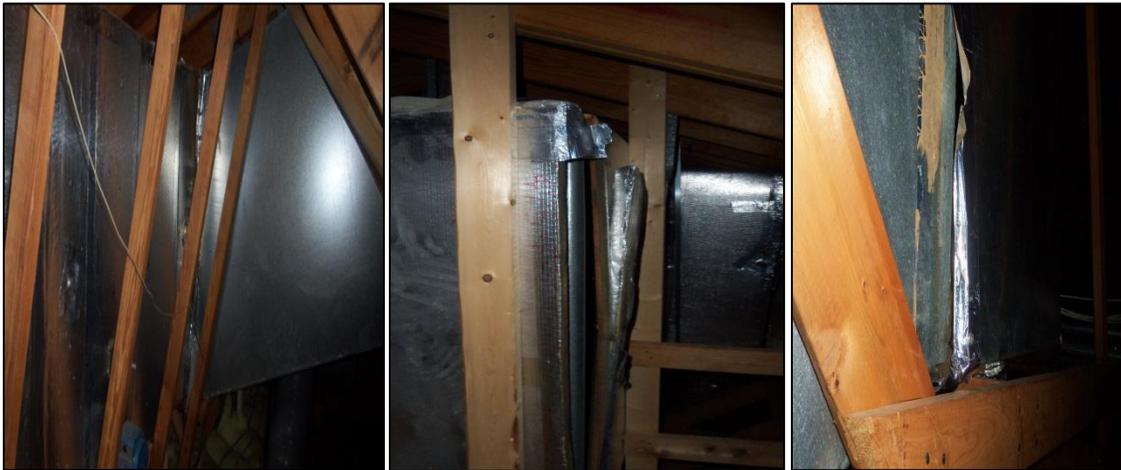
Image 11: Ventilation duct work in the attic with open joints

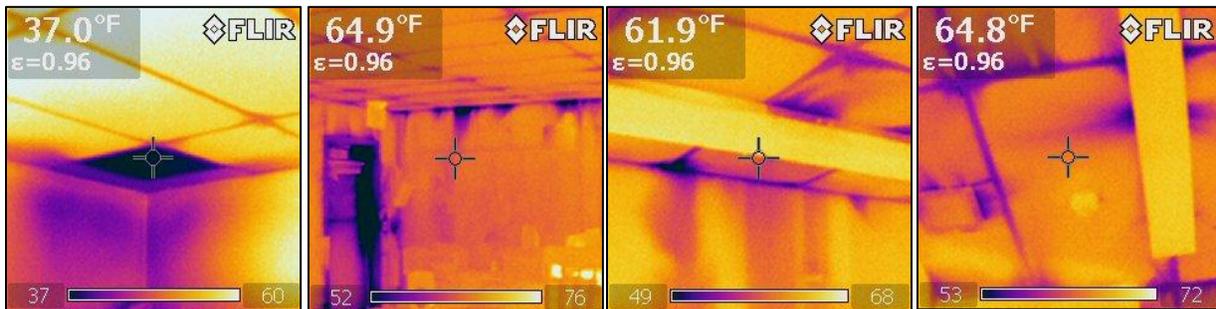
Image 12: Cold air leaking into classrooms from HVAC diffusers, ceiling tiles and fixtures

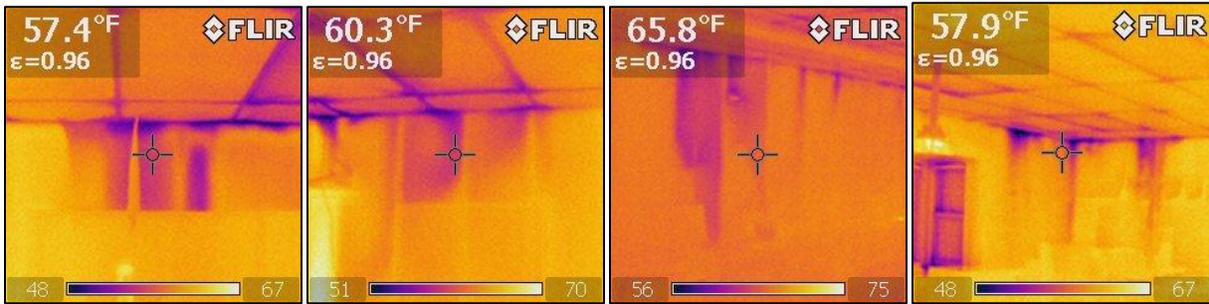
Image 13: Outside air leaking into interior walls from the attic

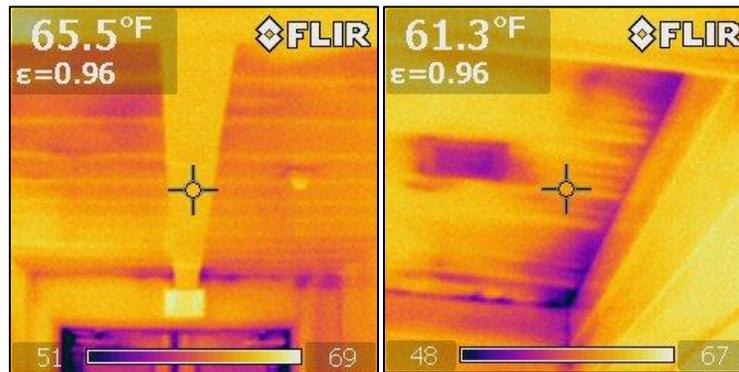
Image 14: The ceiling insulation is not in full contact with the gypsum board air barrier
