**Feasibility Study & Schematic Design  
Phase 2  
Arcove Architects  
ReArch Company, Inc.**

**Mont Vernon Town Hall  
Mont Vernon, NH**

**December 30, 2023**

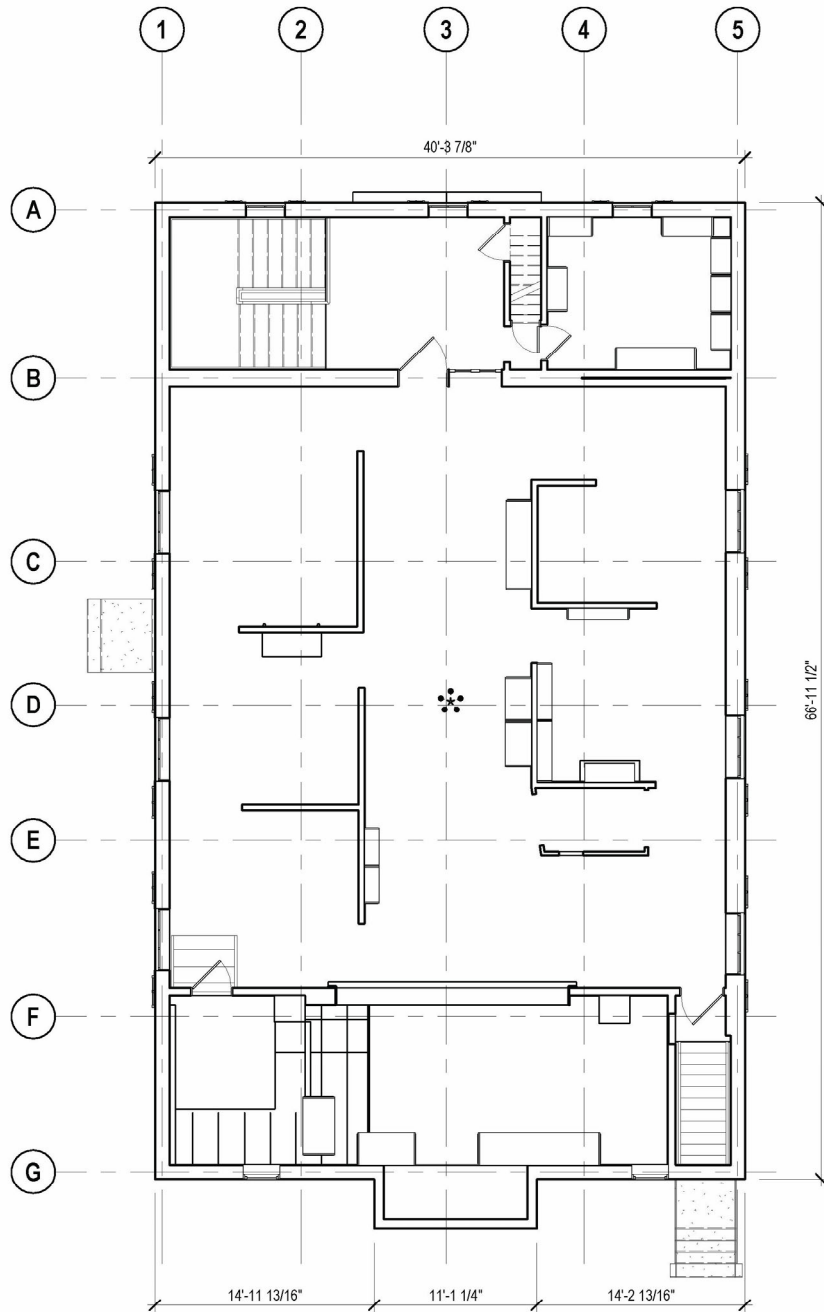
P0.02  
4/28/2023  
PROJECT NO: 1006

1 LEVEL 2 - existing  
1/8" = 1'-0"

SECOND FLOOR PLAN - EXISTING  
MONT VERNON TOWN HALL

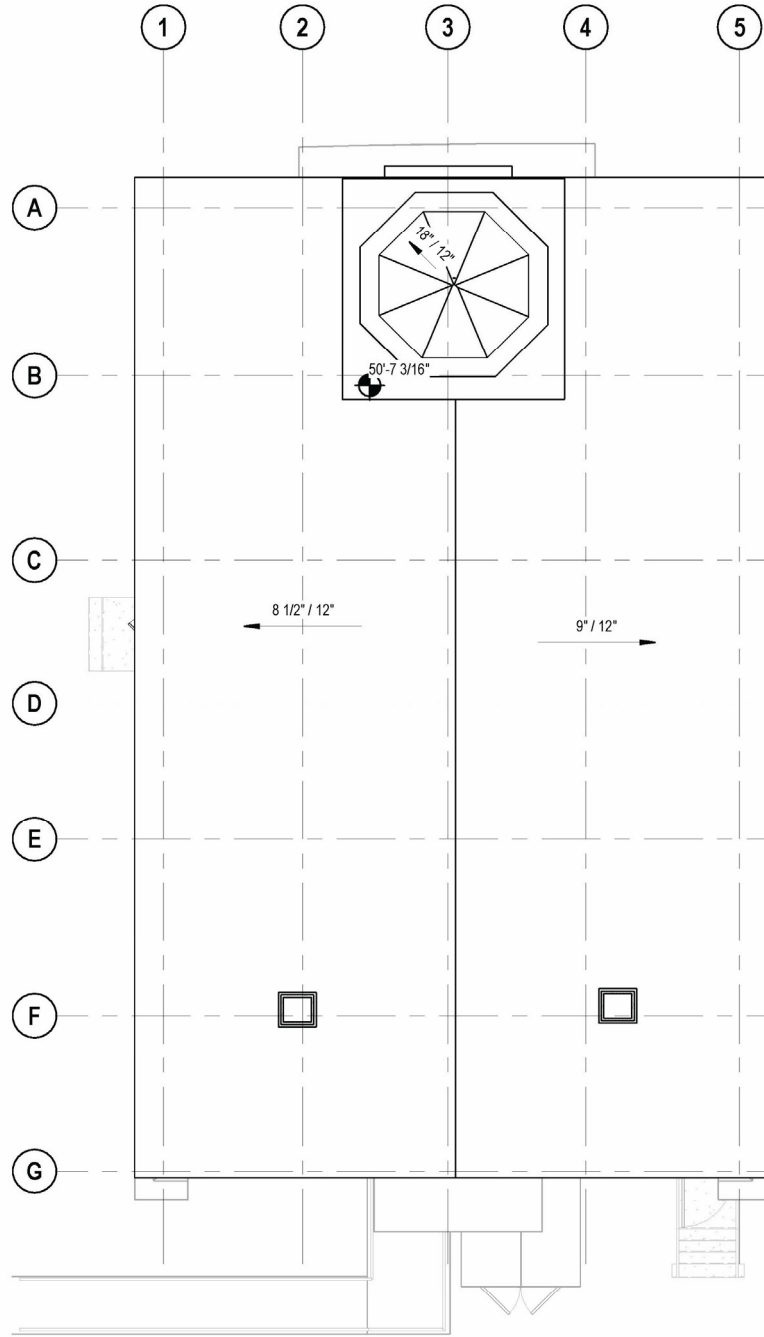
P0.04  
4/28/2023  
PROJECT NO: 1006

1 ROOF - EXISTING  
1/8" = 1'-0"

ROOF PLAN - EXISTING  
MONT VERNON TOWN HALL

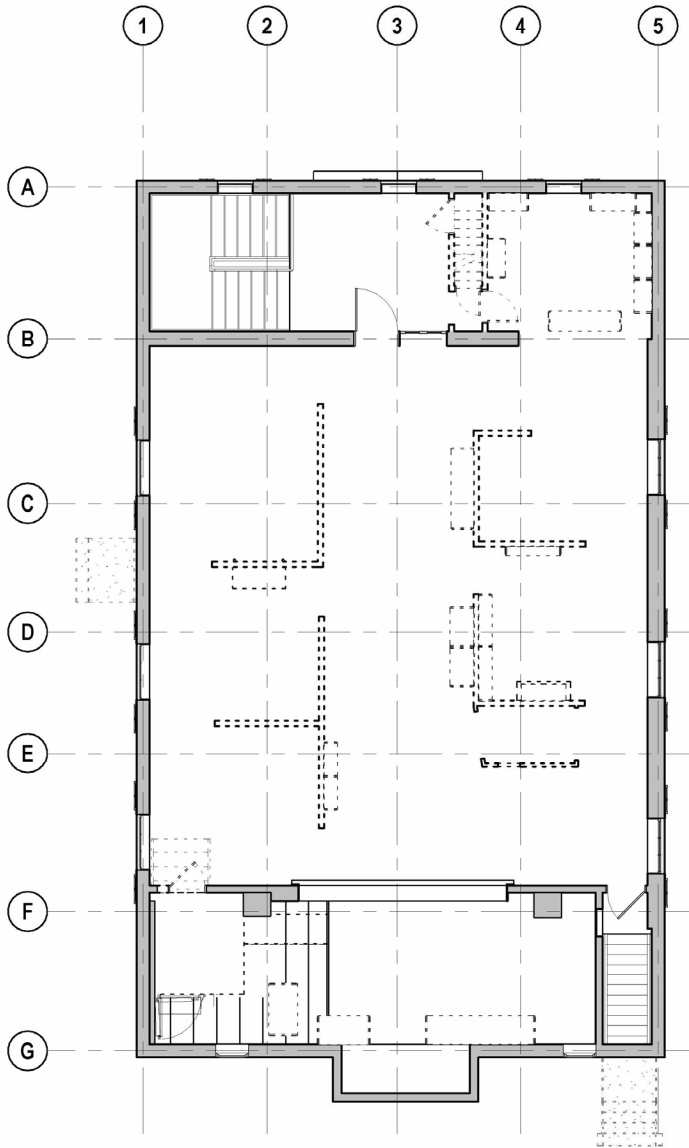
PD1.02  
6/9/2023  
PROJECT NO: 1006

2ND FLOOR DEMOLITION PLAN  
MONT VERNON TOWN HALL

At the second floor, a new platform lift is proposed at the side of stage, for accessibility to the stage. A new and safer stair is proposed to the attic level, along with a new single user, non-handicapped toilet room off of the front upper level lobby.

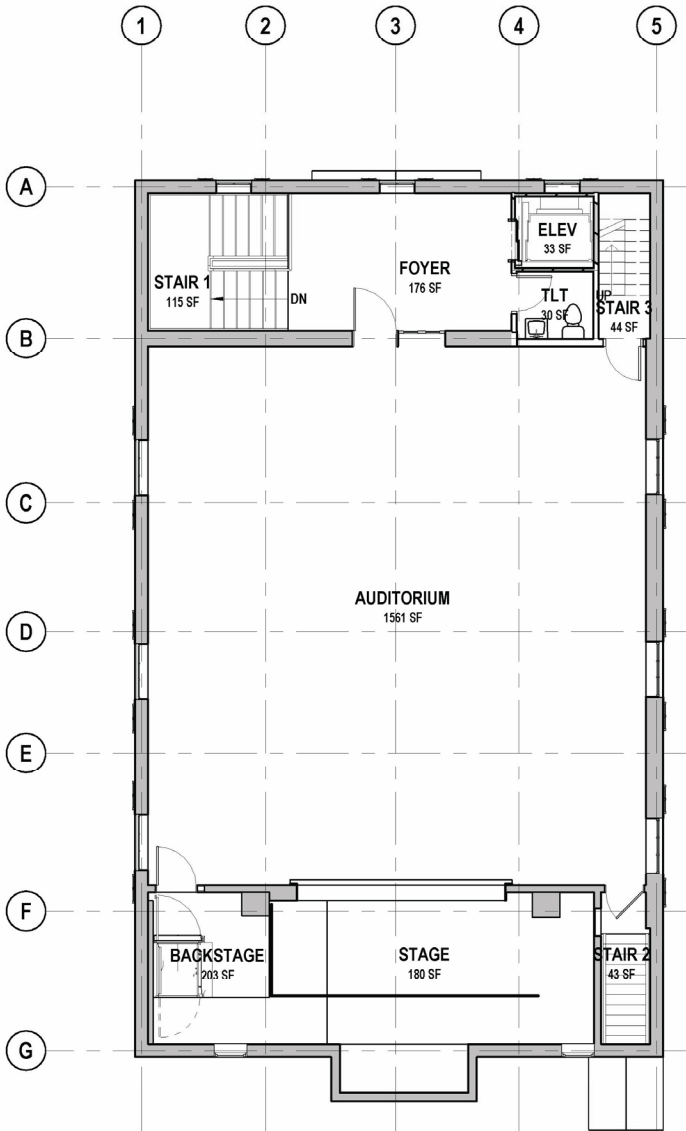
P1.02  
6/01/2023  
PROJECT NO: 1006

2ND FLOOR PLAN  
MONT VERNON TOWN HALL

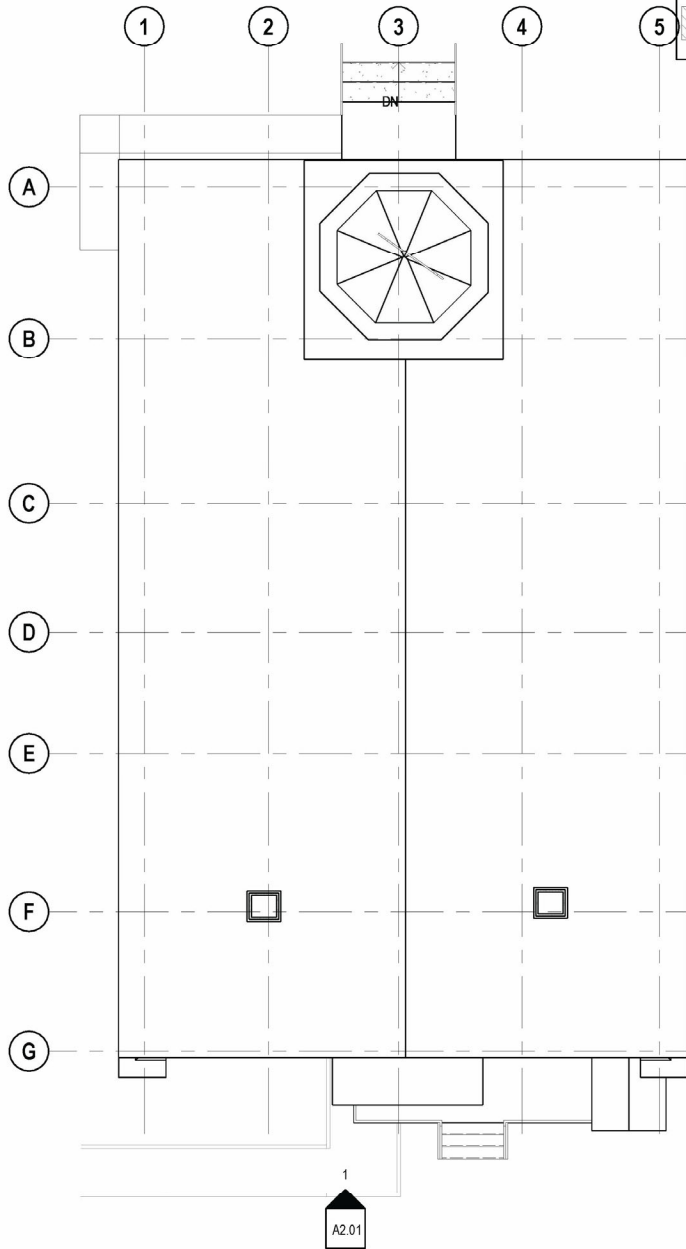
P1.03  
6/01/2023  
PROJECT NO: 1006

ROOF PLAN  
MONT VERNON TOWN HALL

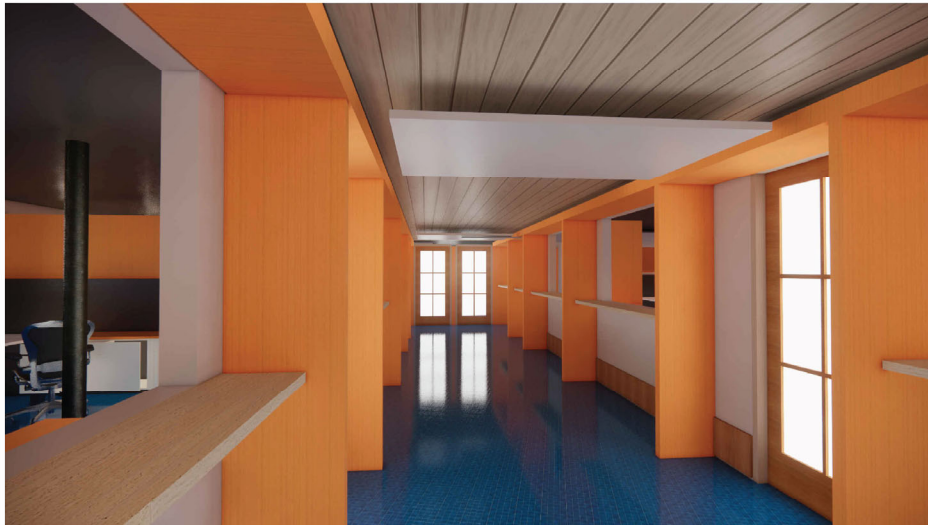
PROPOSED SERVICE CORRIDOR, FIRST FLOOR TOWN OFFICES

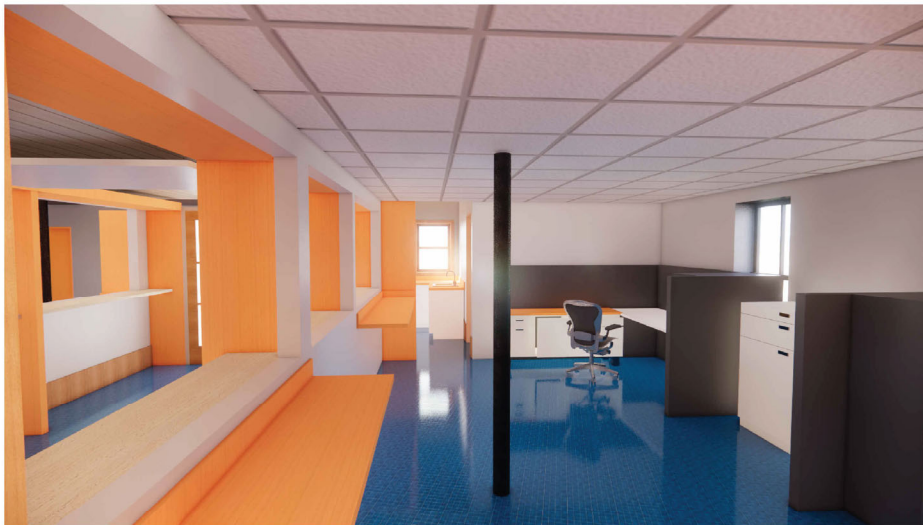
PROPOSED TOWN OFFICES WORK AREA, FIRST FLOOR

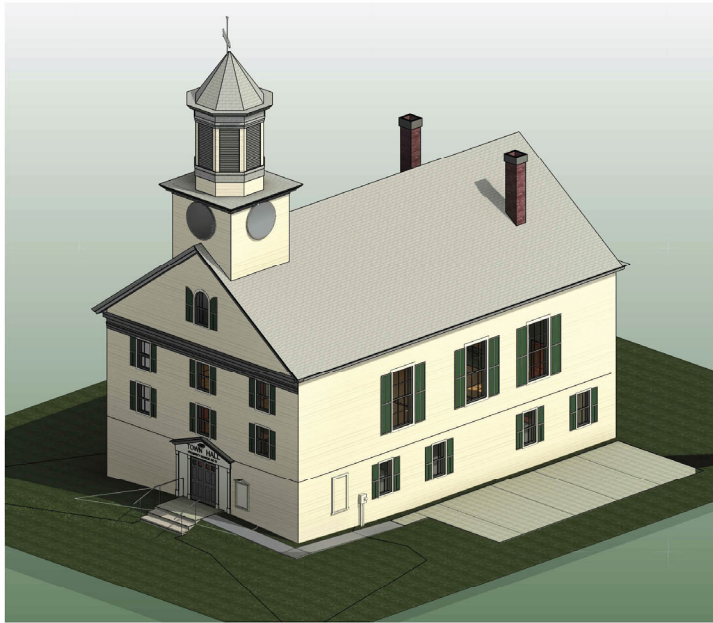
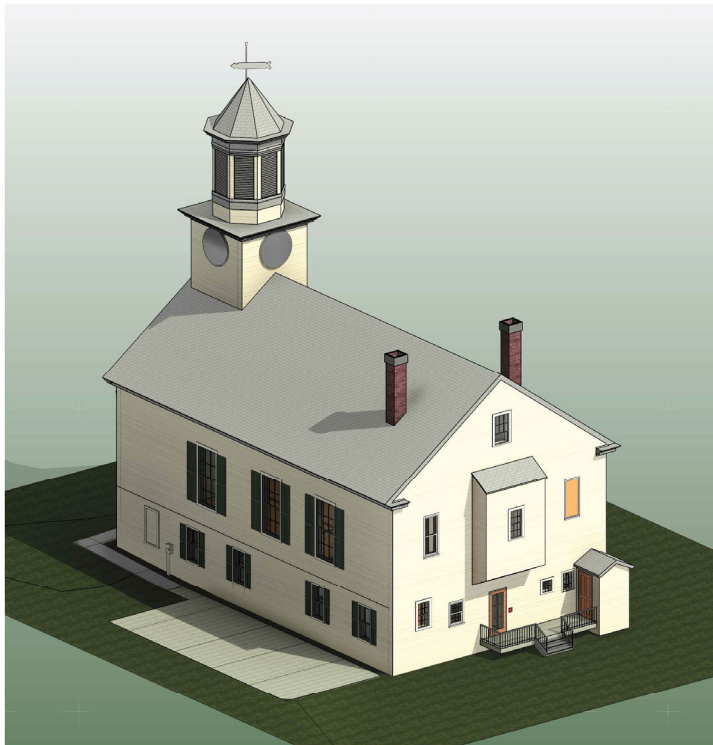
P2.02  
12/30/2023  
PROJECT NO.:1006

1 FRONT AXONOMETRIC

2 REAR AXONOMETRIC

VIGNETTES - EXTERIOR  
MONT VERNON TOWN HALL
