COMPREHENSIVE FACILITIES NEEDS ANALYSIS OF
THE MONT VERNON VILLAGE SCHOOL

OCTOBER 10, 2013

Barker Architects inc.

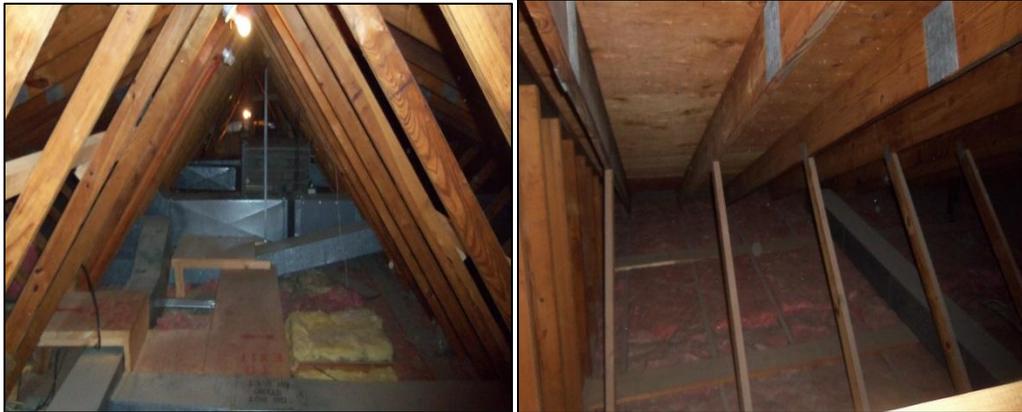
Image 2: Attic truss and R-30 fiberglass insulation design. R-19 fiberglass was also present

The air and thermal barriers in the attic were installed in 2005. Eight years later, the air barrier is in poor condition and no longer performing as a solid air barrier. The attic air barrier has holes and edges/seams that were not sealed during installation. As a result, there is a free flow of conditioned air leaking into the attic (winter conditions) and hot air leaking into the building (summer). The thermal barrier has varying levels of optimal installation. A fiberglass batt that lies flat against an air barrier and is fully encapsulated on all six sides will perform to the listed R-value. Fiberglass batting is never fully encapsulated in attics. However, fiberglass batting can perform quite well if it’s installed properly. Much of the fiberglass batting in the MVS attic was originally installed to manufacturer’s specifications. However, over time the fiberglass batting has fallen down (on the knee walls), been moved and not replaced (during wire or HVAC

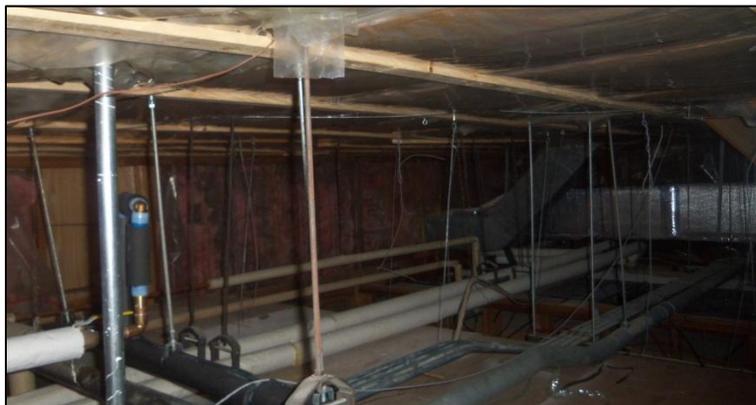
Image 10: Not sure why this HVAC closet over the library was so diligently sealed
